**Rose
Real Estate Inspection
Services**

PROPERTY INSPECTION REPORT

Concerning: 1234 Sample, TX 00000

Date: 0/0/2010

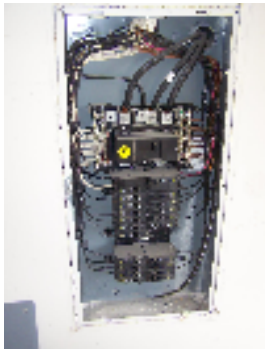
- Exterior: Lateral service; ground rod
- Garage: Square D 200 amp
- Garage: Observed feeder type of wiring is copper.

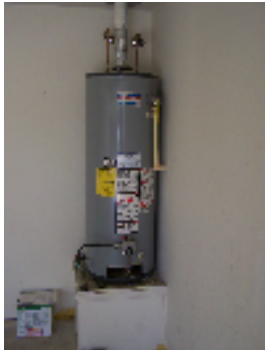
- Garage: American Water Heater - natural gas - 50 gallon
- Garage: Not able to light pilot light for inspection. Gas was turned off at time of inspection.
- Garage: Did not check TPR valve operation due to possible damage of resident's property,

- Garage: Located on the house finish floor level without benefit of a drain pan; should water heater leak interior flooring can be damaged.

- Garage: Located on the house finish floor level without benefit of a drain pan; should water heater leak interior flooring can be damaged.
